Test Report

Sample Name	: LED Signal light

Test item : IP69K

Test standard : ISO 20653: 2013

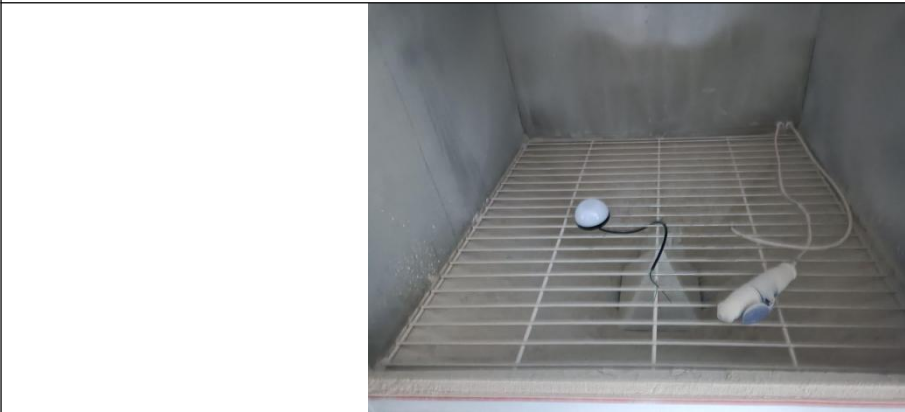
Sample Photo during the Test:

1. Dangerous parts protection test:

1) The test prober of 1 mm diameter is pushed against any opening of the sample with force of 1N.

2. Solid foreign body protection test:

1) Dust type:Arizona dust;

2) Dust content of dust tester:2 kg/m³;

3) Test duration:A, Blowing dust 6 s;B, Stop for 15 minutes.A + B is a cycle, total 20 cycles.

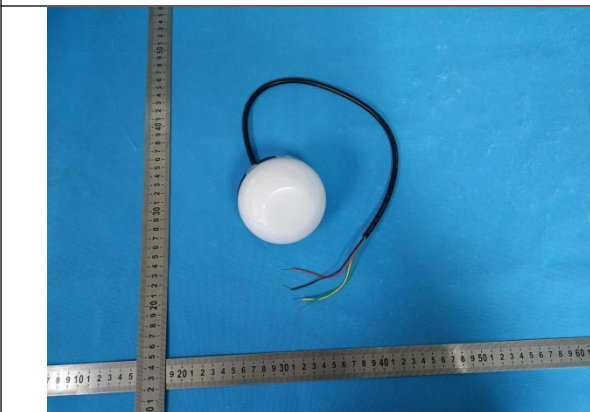
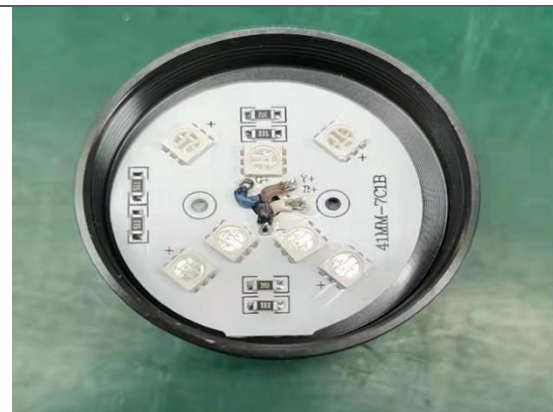
Sample Photo after the Test:

Sample No.	Test result	Judge
211123008C-001	After the test, no dust entered into the sample.	PASS

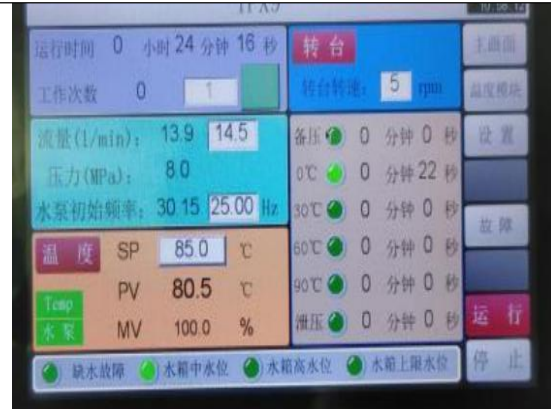
Sample Photo during the Test:

Water temperature	80±5°C
Pressure	(8000~10000kPa)
Water flow	14~16L/min
Distance	10~15CM
Angle and time	0°,30°,60°,90°,30s per angle

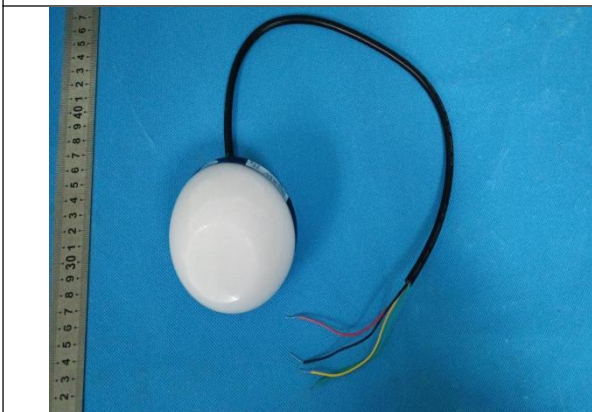
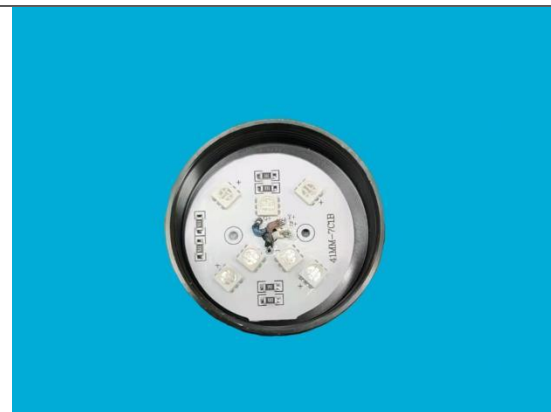
Sample Photo after the Test:

Sample No.	Test result	Judge
211011008C-001	After the test, no water entered the sample.	PASS
